DEPARTMENT OF TRANSPORTATION

Quality Assurance and Source Inspection

Contract #: 04-0120F4Cty: SF/ALA Rte: 80 PM: 13.2/13.9File #: 69.28**WELDING INSPECTION REPORT****Resident Engineer:**Pursell, Gary**Address:** 333 Burma Road**City:** Oakland, CA 94607**Report No:** WIR-016358**Date Inspected:** 16-Aug-2010**Project Name:** SAS Superstructure**OSM Arrival Time:** 700**Prime Contractor:** American Bridge/Fluor Enterprises, a JV**OSM Departure Time:** 1900**Contractor:** Zhenhua Port Machinery Company, Ltd (ZPMC), Changxing Island **Location:** Shanghai, China

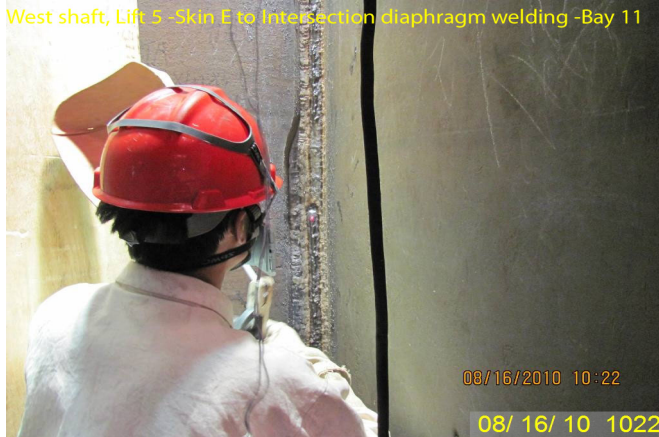
4. This QA inspector, Baskar Govindarajan, observed, ZPMC qualified welding personnel identified as 070006 perform SMAW welding on; West shaft, Lift 5, Intersection diaphragm plate to Skin E (Outside) and the weld joint is identified as WSD1-TL5-4B/F-07. ZPMC CWI Identified as Mr. Yu Dong Ping. The welding parameters as measured using QC's calibrated instruments appeared to be in general compliance with WPS-B-T-3213-TC-U4c. (Photo attached)

West shaft, Lift 5 - Skin E to Intersection diaphragm welding -Bay 11

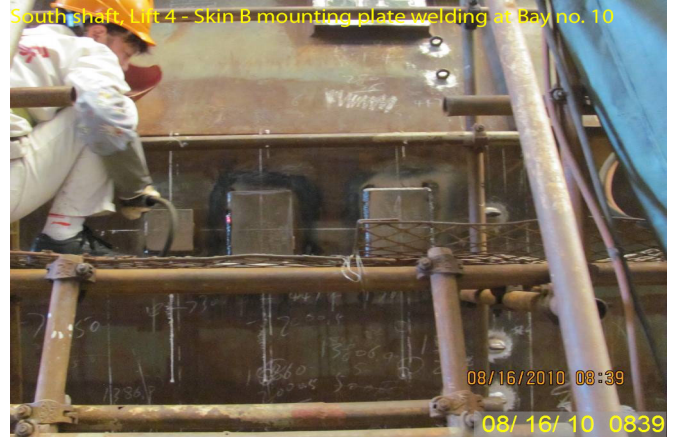
2. This QA inspector, Baskar Govindarajan, observed, ZPMC qualified welding personnel identified as 040521 perform SMAW welding on; South shaft, Lift 4, Mounting plate on Skin B and the weld joint is identified as CAMPSA4-14,15,16. ZPMC CWI Identified as Mr. Qiu Wen. The welding parameters as measured using QC's calibrated instruments appeared to be in general compliance with WPS-B-P-2113 and WPS-B-P-2112. (Photo attached)

South shaft, Lift 4 - Skin B mounting plate welding at Bay no. 10

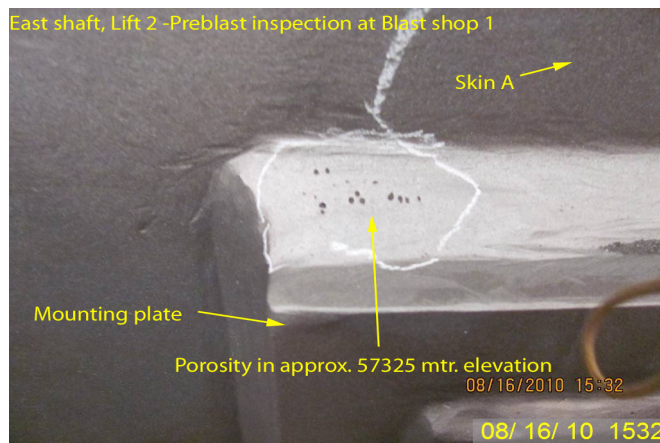
7. This QA inspector, Baskar Govindarajan, performed Pre blast inspection of external surfaces of East tower, Lift 2. All the areas marked which requires grinding, weld repair, Grinding & MT wherever applicable in all the Skins of Tower from 50.3 to 83 mtr. Elevation. This inspection was carried out along with QA Inspector Mr. Sandeep Kumar whose lot no. is B 227, Mr. Bera (B 205), Mr. Sugunthan (B 248), Mr. Gade (B 307) and Mr. Art Peterson . All the marked points shown to ZPMC inspector Mr. Zhao Chen Sun and ABF Inspector Mr. Chen. All the weld repair areas (13 nos) marked in weld map in detail and the same was signed by ZPMC and ABF Inspector. Mr. James Lumley, QA NACE Level III Inspector was present during the inspection process. (Photos attached)

East shaft, Lift 2 -Preblast inspection at Blast shop 1

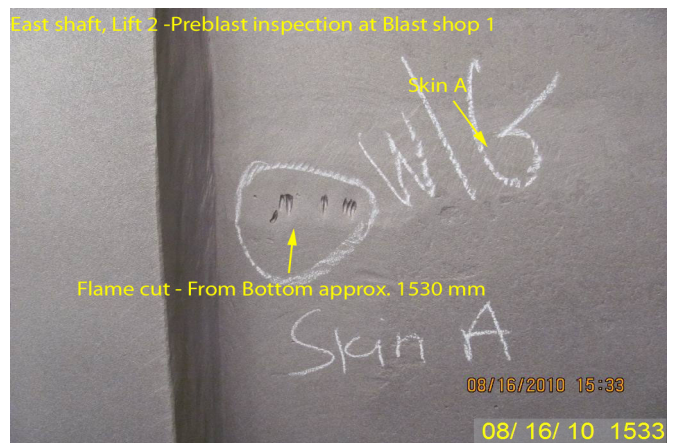
East shaft, Lift 2 -Preblast inspection at Blast shop 1
